Date: 17/04/2014		Test Report : TR2014027	Page 1 of 8
Department	Height Safety	Test: Static pull test on life vest toggle handles	Ref: QSI 20140417-01

Client: Safe Defence LTD
92 Annett Road
RD1 – Kumeu
Auckland 0891
New Zealand

Test specification: Test to determine the breaking strength of the jacket release cord handles and the minimum force required to activate the actuator unit.

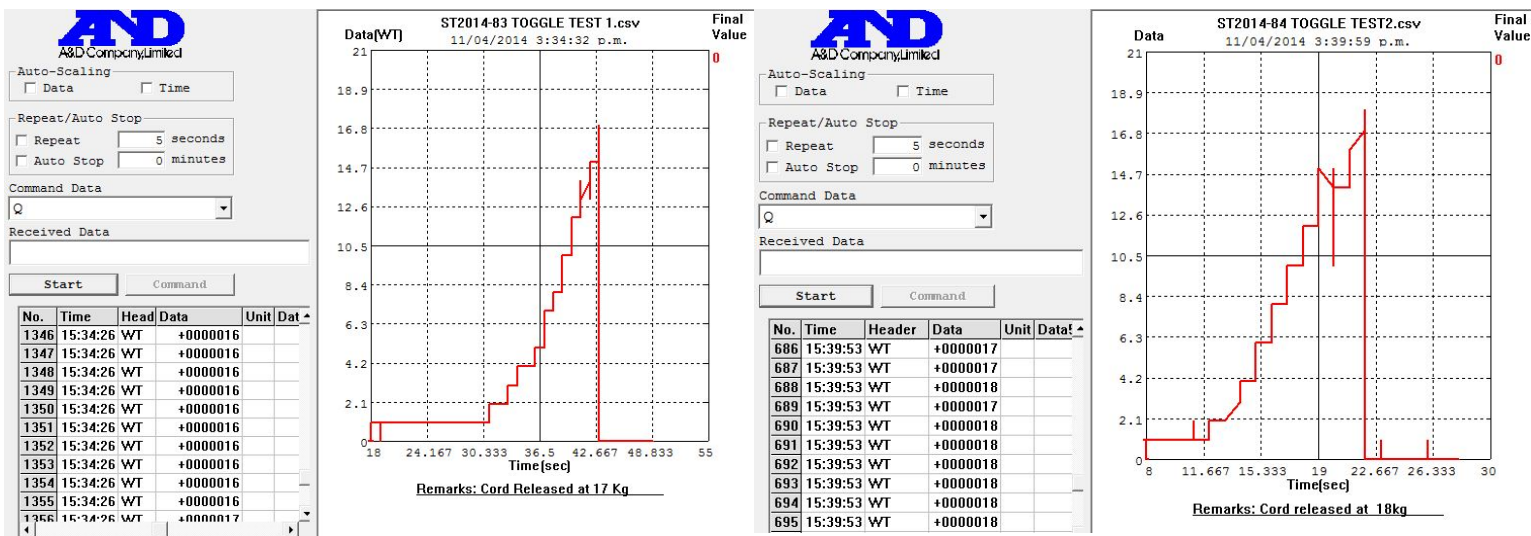
Appendix 1 (Standard handle as supplied)

Test Number	Description	Break Force Recorded
ST2014-83	Toggle number 1	17 Kg
ST2014-84	Toggle number 2	18 Kg
ST2014-85	Toggle number 3	23 Kg
ST2014-86	Toggle number 4	36 Kg
ST2014-87	Toggle number 5	20 Kg
ST2014-88	Toggle number 6	31 Kg
Average		24 Kg

The Safe Defence toggle handles as provided broke at a force of 24kg on average out of the six (6) tested.

Refer to appendix 1 for graphs

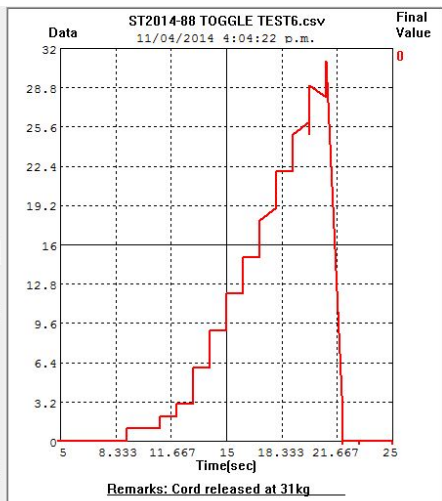
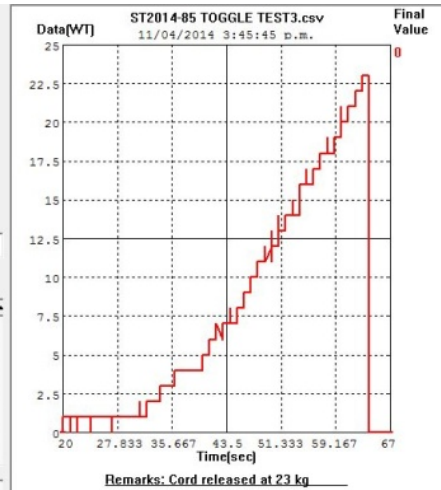
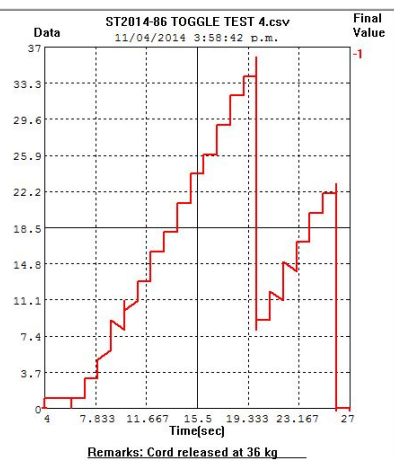
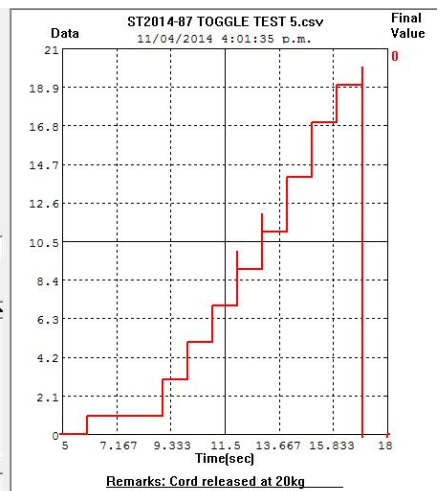
Appendix 1 (Standard handle as supplied continued)

No.	Time	Header	Data	Unit	Data5
658	16:04:17	WT	+0000031		
659	16:04:17	WT	+0000031		
660	16:04:17	WT	+0000031		
661	16:04:17	WT	+0000031		
662	16:04:17	WT	+0000031		
663	16:04:17	WT	+0000031		
664	16:04:17	WT	+0000031		
665	16:04:17	WT	+0000031		
666	16:04:18	WT	+0000002		
667	16:04:18	WT	+0000000

No.	Time	Header	Data	Unit	Data5
2002	15:45:38	WT	+0000023		
2003	15:45:38	WT	+0000023		
2004	15:45:38	WT	+0000023		
2005	15:45:38	WT	+0000023		
2006	15:45:38	WT	+0000023		
2007	15:45:38	WT	+0000023		
2008	15:45:38	WT	+0000023		
2009	15:45:38	WT	+0000023		
2010	15:45:38	WT	+0000023		
2011	15:45:38	WT	+0000005		
2012	15:45:38	WT	+0000000

No.	Time	Header	Data	Unit	Data5
626	15:58:32	WT	+0000035		
627	15:58:32	WT	+0000035		
628	15:58:32	WT	+0000035		
629	15:58:32	WT	+0000035		
630	15:58:32	WT	+0000035		
631	15:58:32	WT	+0000036		
632	15:58:32	WT	+0000036		
633	15:58:32	WT	+0000035		
634	15:58:32	WT	+0000010		
635	15:58:32	WT	+0000008		
636	15:58:32	WT	+0000000

No.	Time	Header	Data	Unit	Data5
538	16:01:32	WT	+0000020		
539	16:01:32	WT	+0000020		
540	16:01:32	WT	+0000020		
541	16:01:32	WT	+0000020		
542	16:01:32	WT	+0000020		
543	16:01:32	WT	+0000020		
544	16:01:32	WT	+0000020		
545	16:01:32	WT	+0000020		
546	16:01:32	WT	+0000020		
547	16:01:32	WT	+0000020

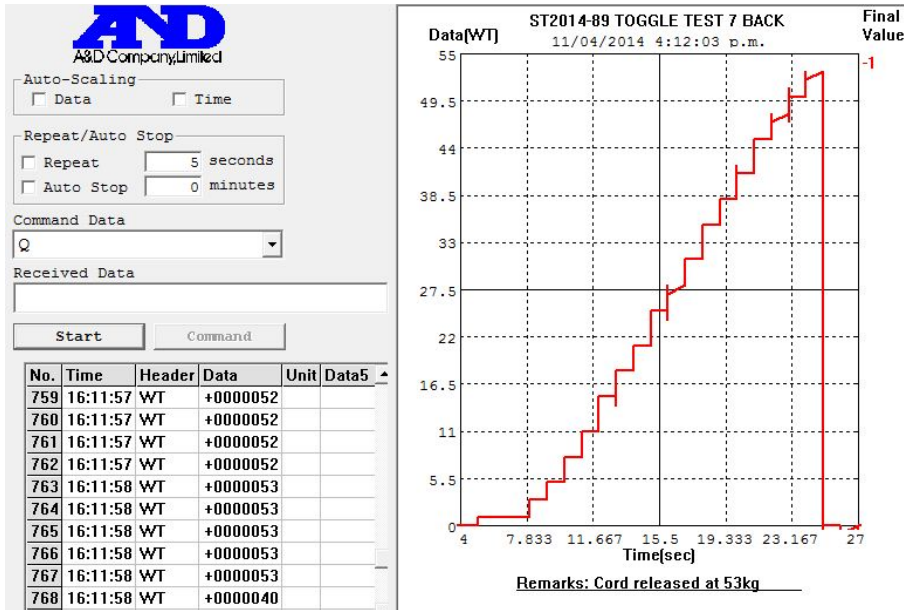
Appendix 2 (Handle with extra back tac)

Test Number	Description	Break Force Recorded
ST2014-89	Toggle with one extra stitch above press stud	53 Kg

The extra stitching added additional strength and allowed the cord to hold up to 53 Kg. (Refer to appendix 2)

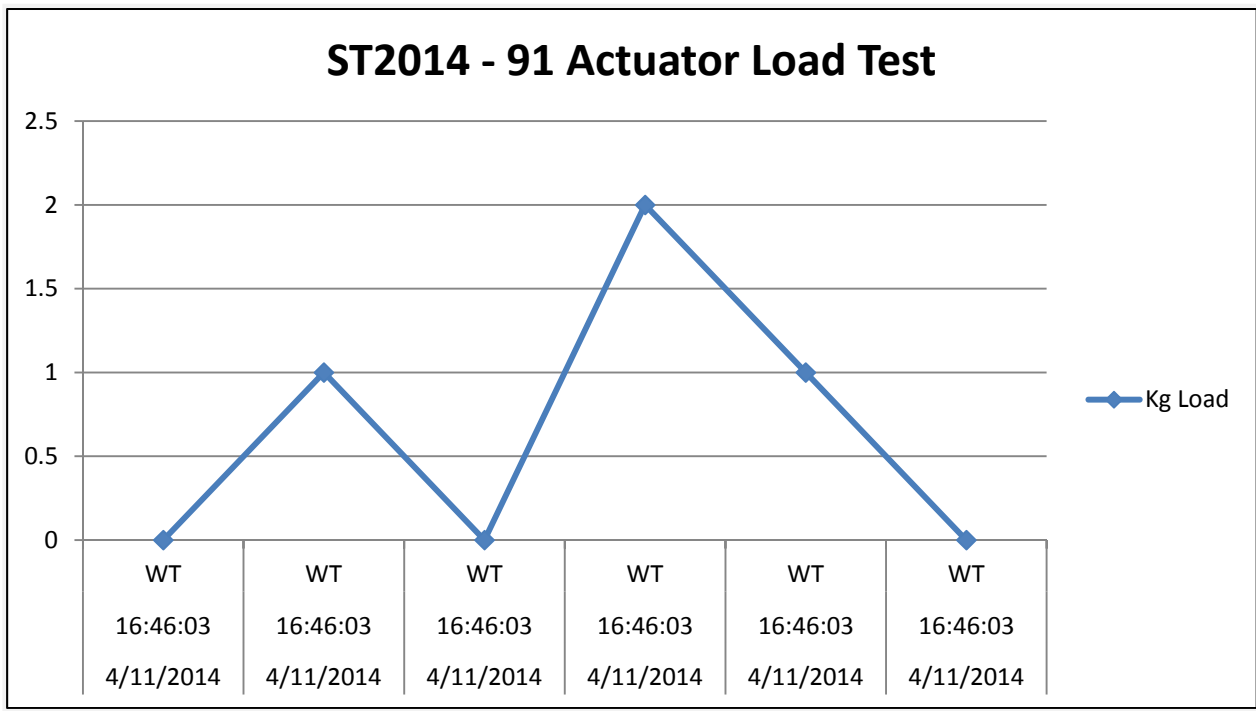
Appendix 3 (Actuator unit)

As per the graph, we had 2 readings, one at 1Kg and one at 2Kg when the cord reached the end of the swivel cycle and snapped out the plastic holder. Our test cell can only read in 1 Kg increments and the actuator could have released at a lower weight and logged in at 1Kg. (Refer to appendix 3)

Graph needed to be plotted in XL as all readings took place in .03 of a second.
 Unit snapped out of plastic housing at 2kg as it was not the complete unit fixed in the vest.

The actuator unit released at 1 kg and broke out the plastic housing at 2kg.

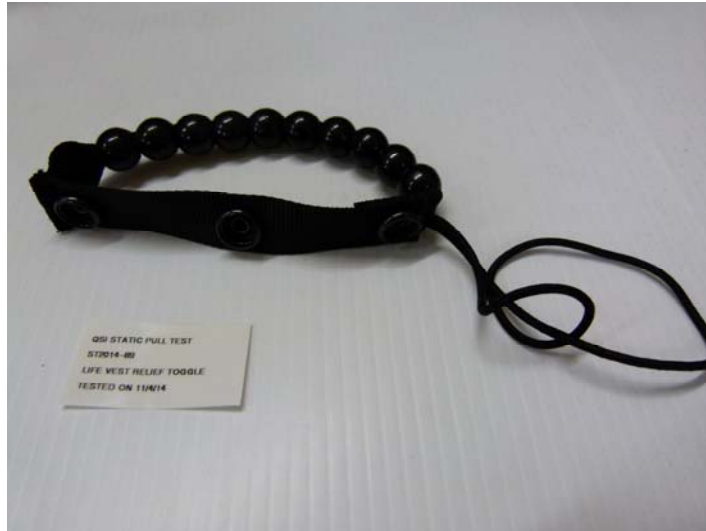
1. Standard toggle handle as provided to QSI for testing

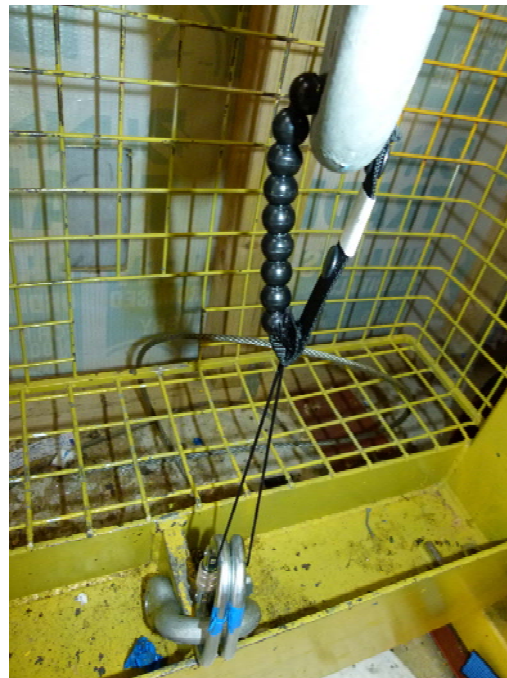
2. Setup of pull test unit to generate consistent pull test results, cross head speed set to 120mm / minute

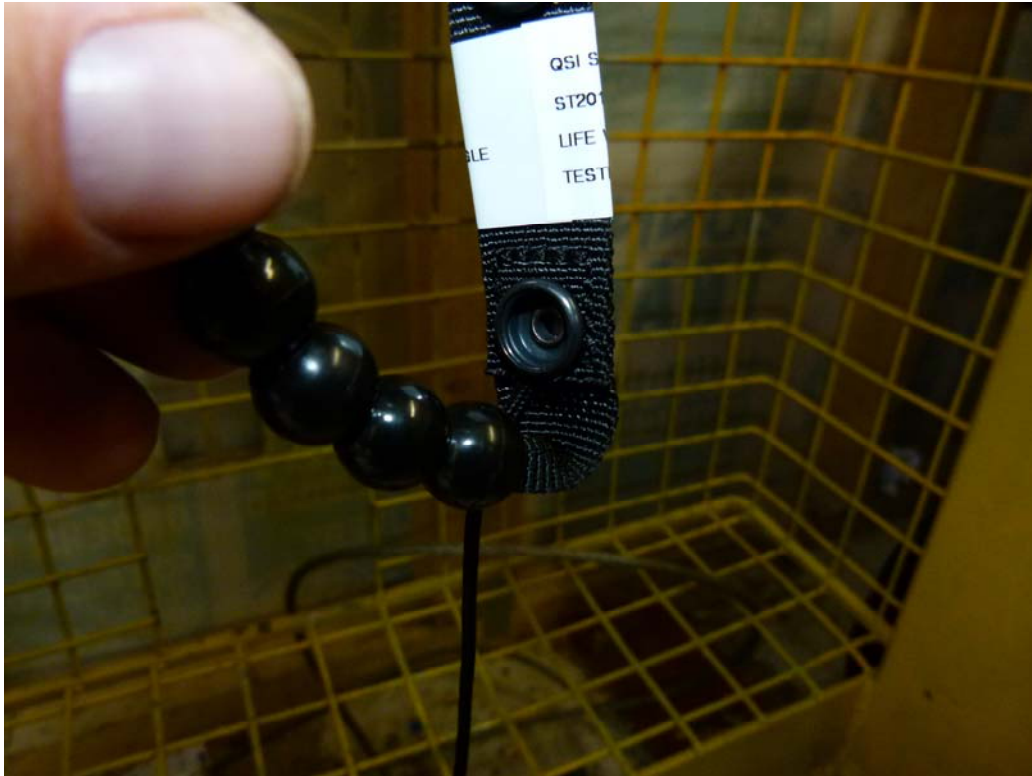
3. Cord released from one of the sides from underneath the press stud on all six tests.

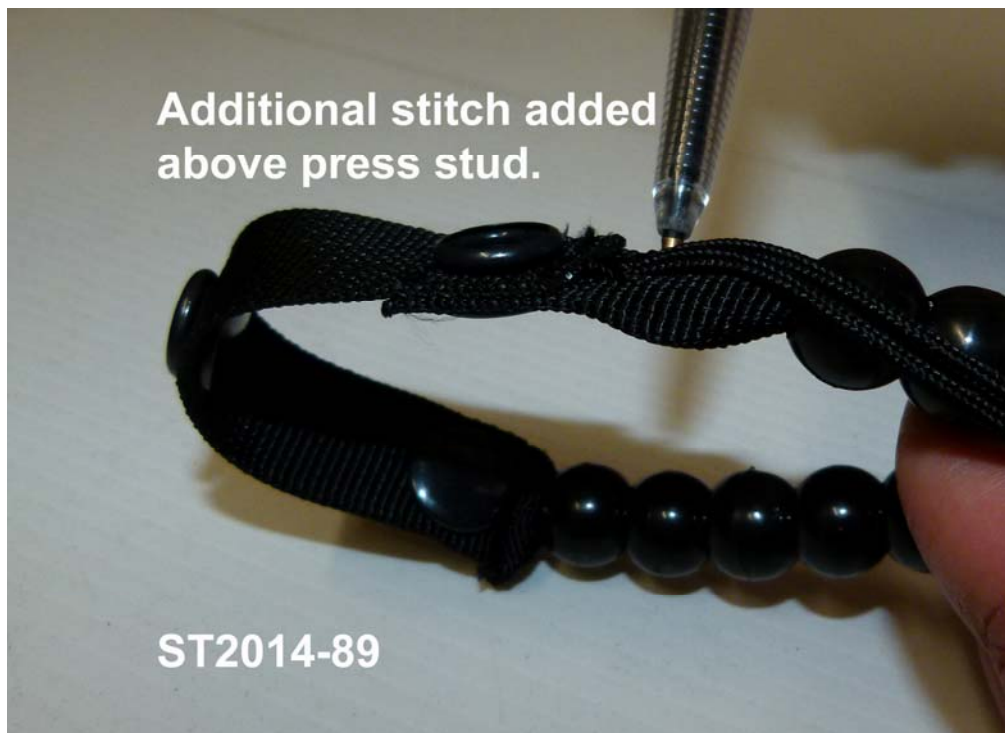
4. The additional stitch prevented the cord from pulling out from underneath the press stud and added an additional 20kg's strength to the units.

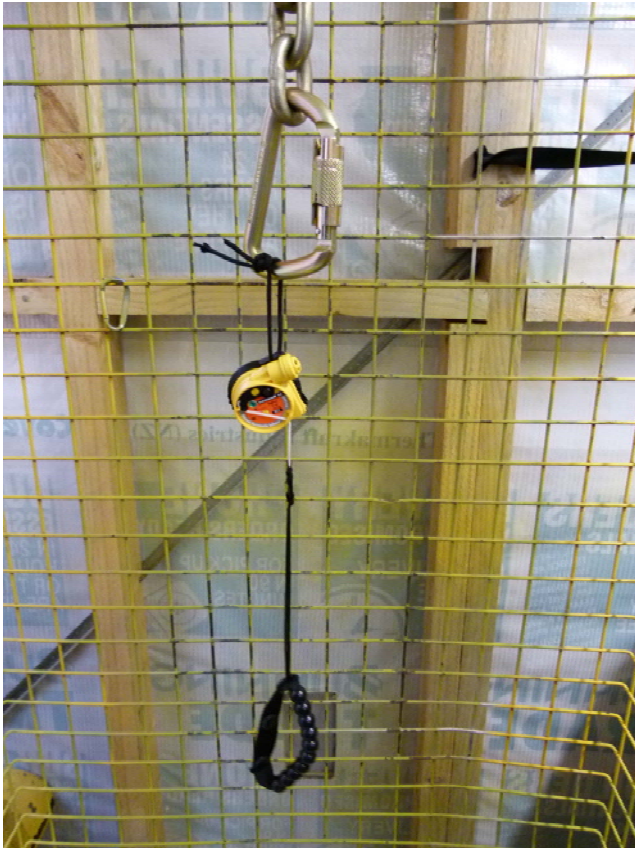
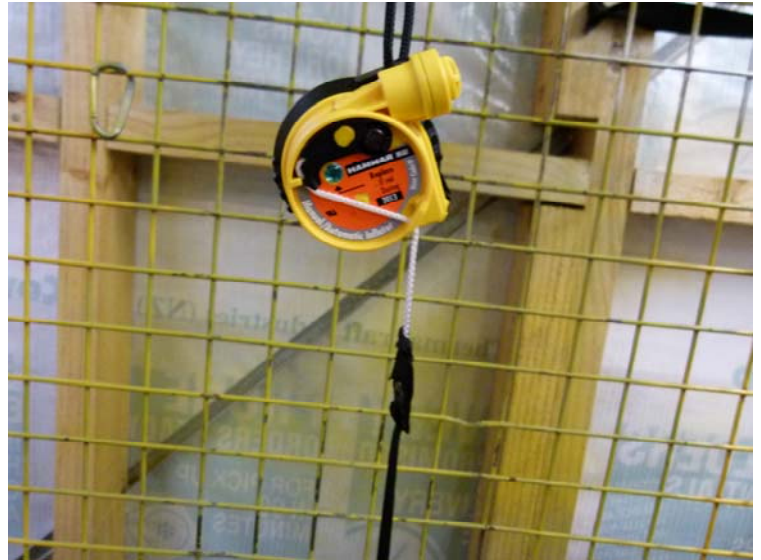
5. Actuator was activated by pulling it by hand, it clipped out of the black plastic housing at 2kg force due to the sudden pull exerted on the unit.
Due to the cost of the unit only one unit was needed to gauge the force required to activate it.
